EPA R6 Dive Team Operations Report

San Jacinto Waste Pits
Channelview, TX
December 9-10, 2015

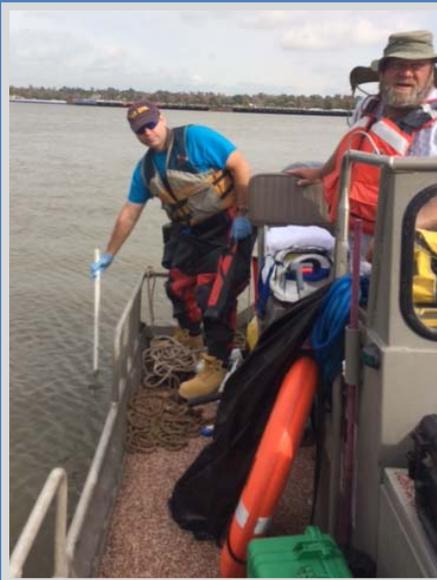
Image 1:

Location A.1 - On Wednesday, 12/9, the tethered diver entered the river at location A.1 on foot in an attempt to walk into deeper water. The diver was not able to walk because he sank into the silty bottom in the area immediately adjacent to the boat. Hard rock was not encountered at the river bottom in the immediate area of boat and diver. Diver was relocated to A.2 On Thursday, 12/10, the team returned back to this location to perform further investigation. In order to better define the area where rock was not present, a calibrated plastic pole (probe) operated from the boat was used to determine the presence/absence of rock at 4 GPS coordinates (see Map). Probe locations indicate the hole is at least 17 ft across.

After penetrating multiple feet into the sediment, the white plastic pole was covered with a thick, grey, sludge-like material when brought to the surface (Image 1, Image 2, and Image 3). This material is not similar in nature to the flocculent sediment identified at other areas of the cap.

Insertion of probe adjacent to location A.1 where rock is not present.

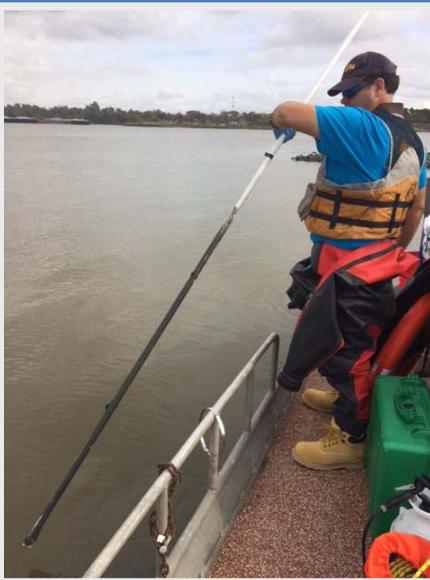
Image 2:

Probe brought to the surface after sediment penetration adjacent to location A.1.

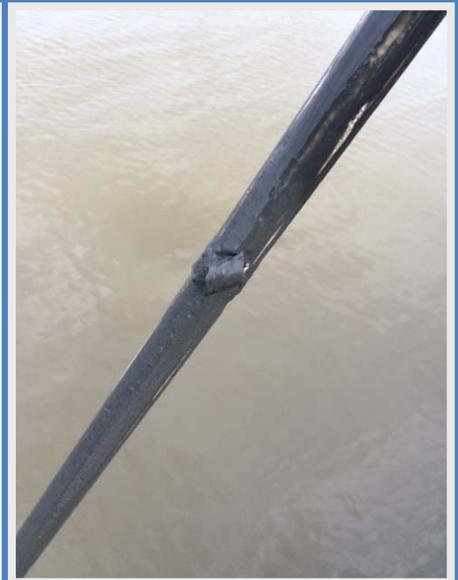
Image 3:

Thick, grey, sludge-like material on probe after sediment penetration adjacent to A.1.

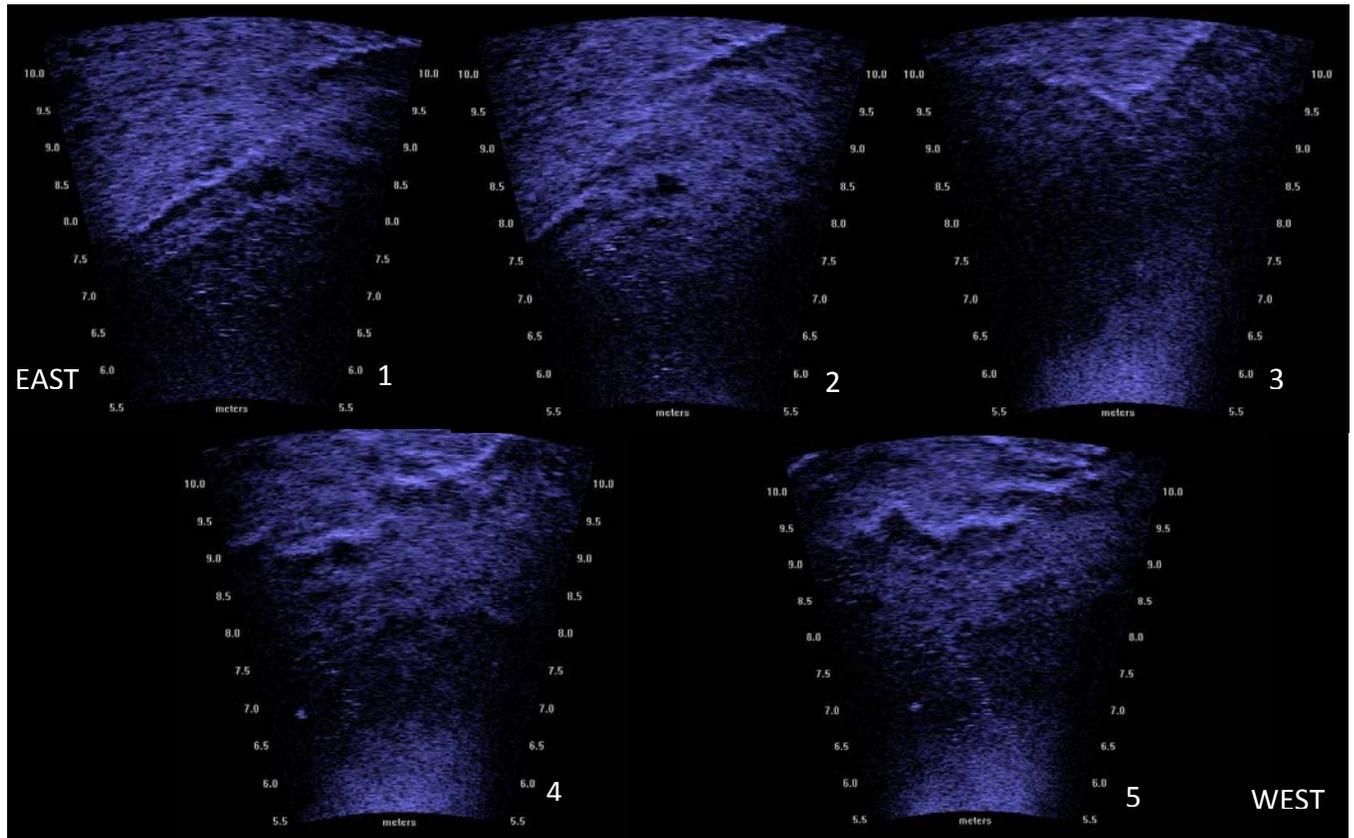
Imaging sonar was utilized in this area in an attempt to visualize the area of deficiency. This area was not identifiable via sonar, but other areas of interest were identified based on changes in color within the sonar image (Image 4 and Map). A tethered diver was used to physically inspect these areas. Rock was found to be present throughout these areas. Two factors introduced difficulty during sonar operation. Wind-driven movement of the boat distorted sonar imagery. Usefulness of the sonar was limited to areas that were covered with little to no sediment. This condition existed in areas of the cap with sloping bathymetry.

Image 4: Sonar Images of armored cap. Appearing in order from East to West and top of the image pointing South towards the shoreline.

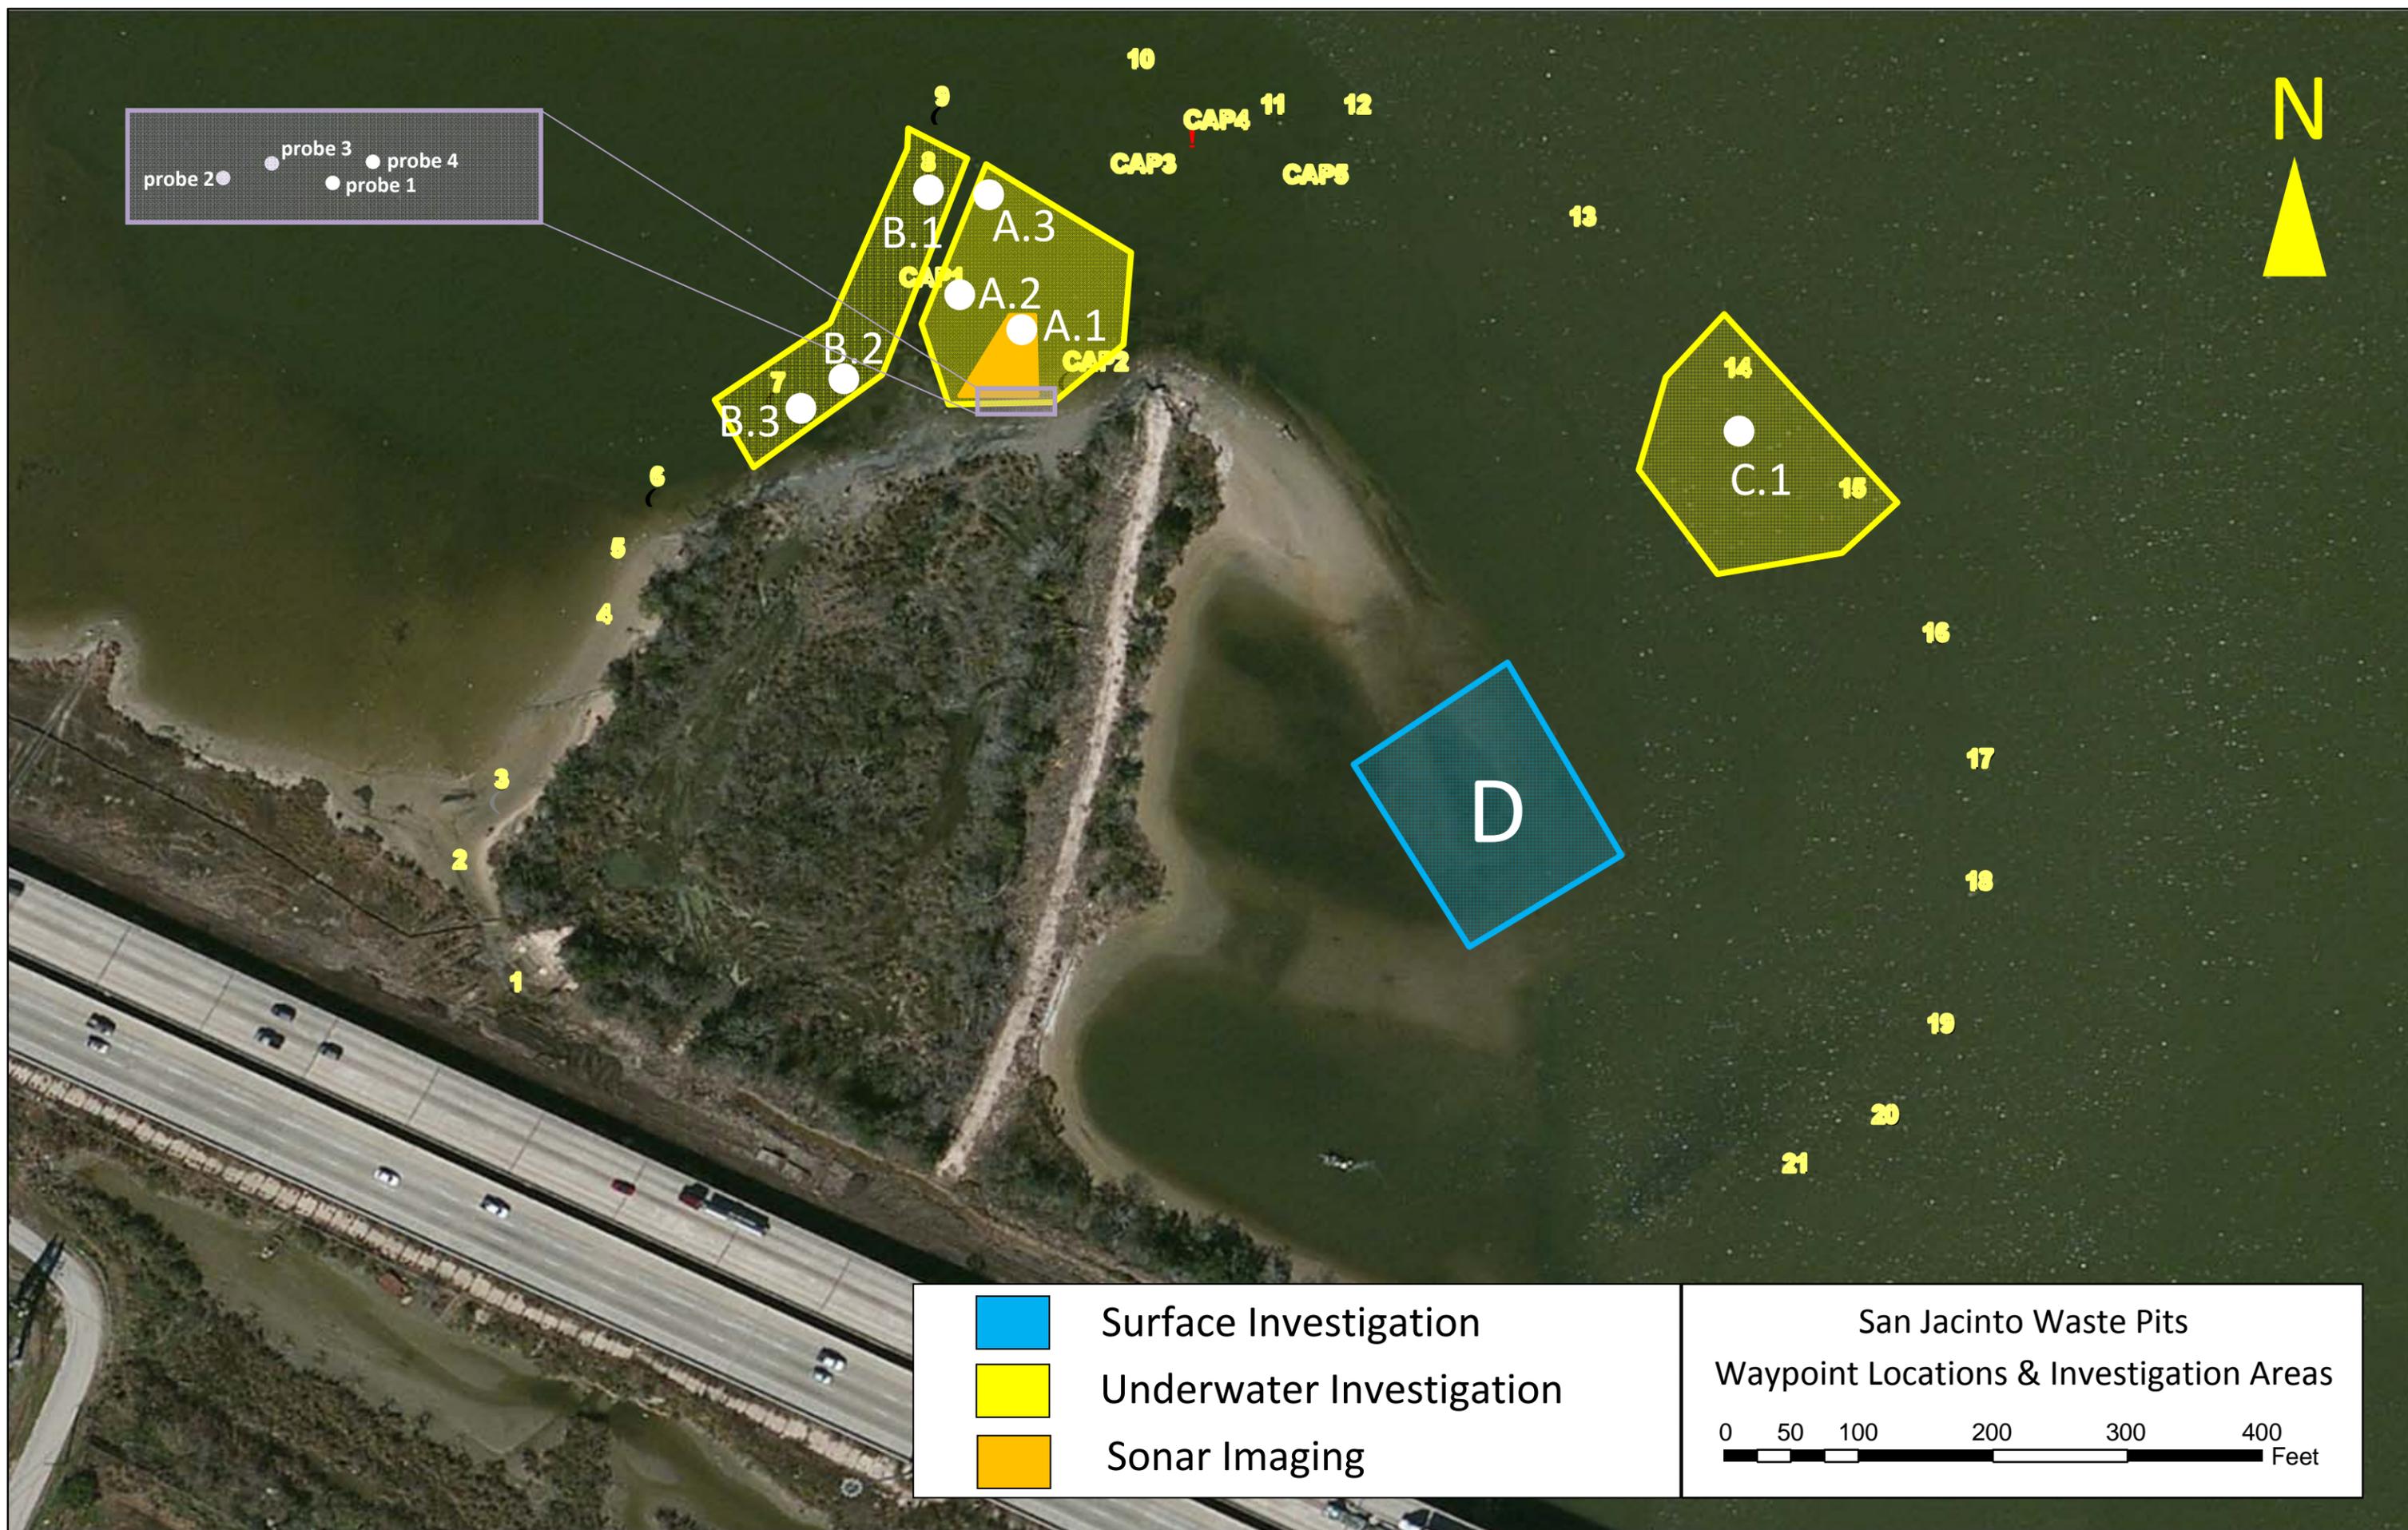
San Jacinto Waste Pits
Waypoint Locations & Investigation Areas

Location	Longitude	Latitude	Observations
probe 1	-95.062986	29.795421	Rock not present to a depth of at least 6 ft
probe 2	-95.063084	29.795416	Rock Present
probe 3	-95.063038	29.795428	Rock not present to a depth of at least 6 ft
probe 4	-95.062956	29.795437	Rock Present
