Figure 4
Results of Sediment Sampling Conducted on December 23, 2015 in Close Up
TEQ_{DF} (ng/kg dw)
Pre-maintenance Armored Cap
Surface Sediment Sampling Report
San Jacinto River Waste Pits Superfund Site

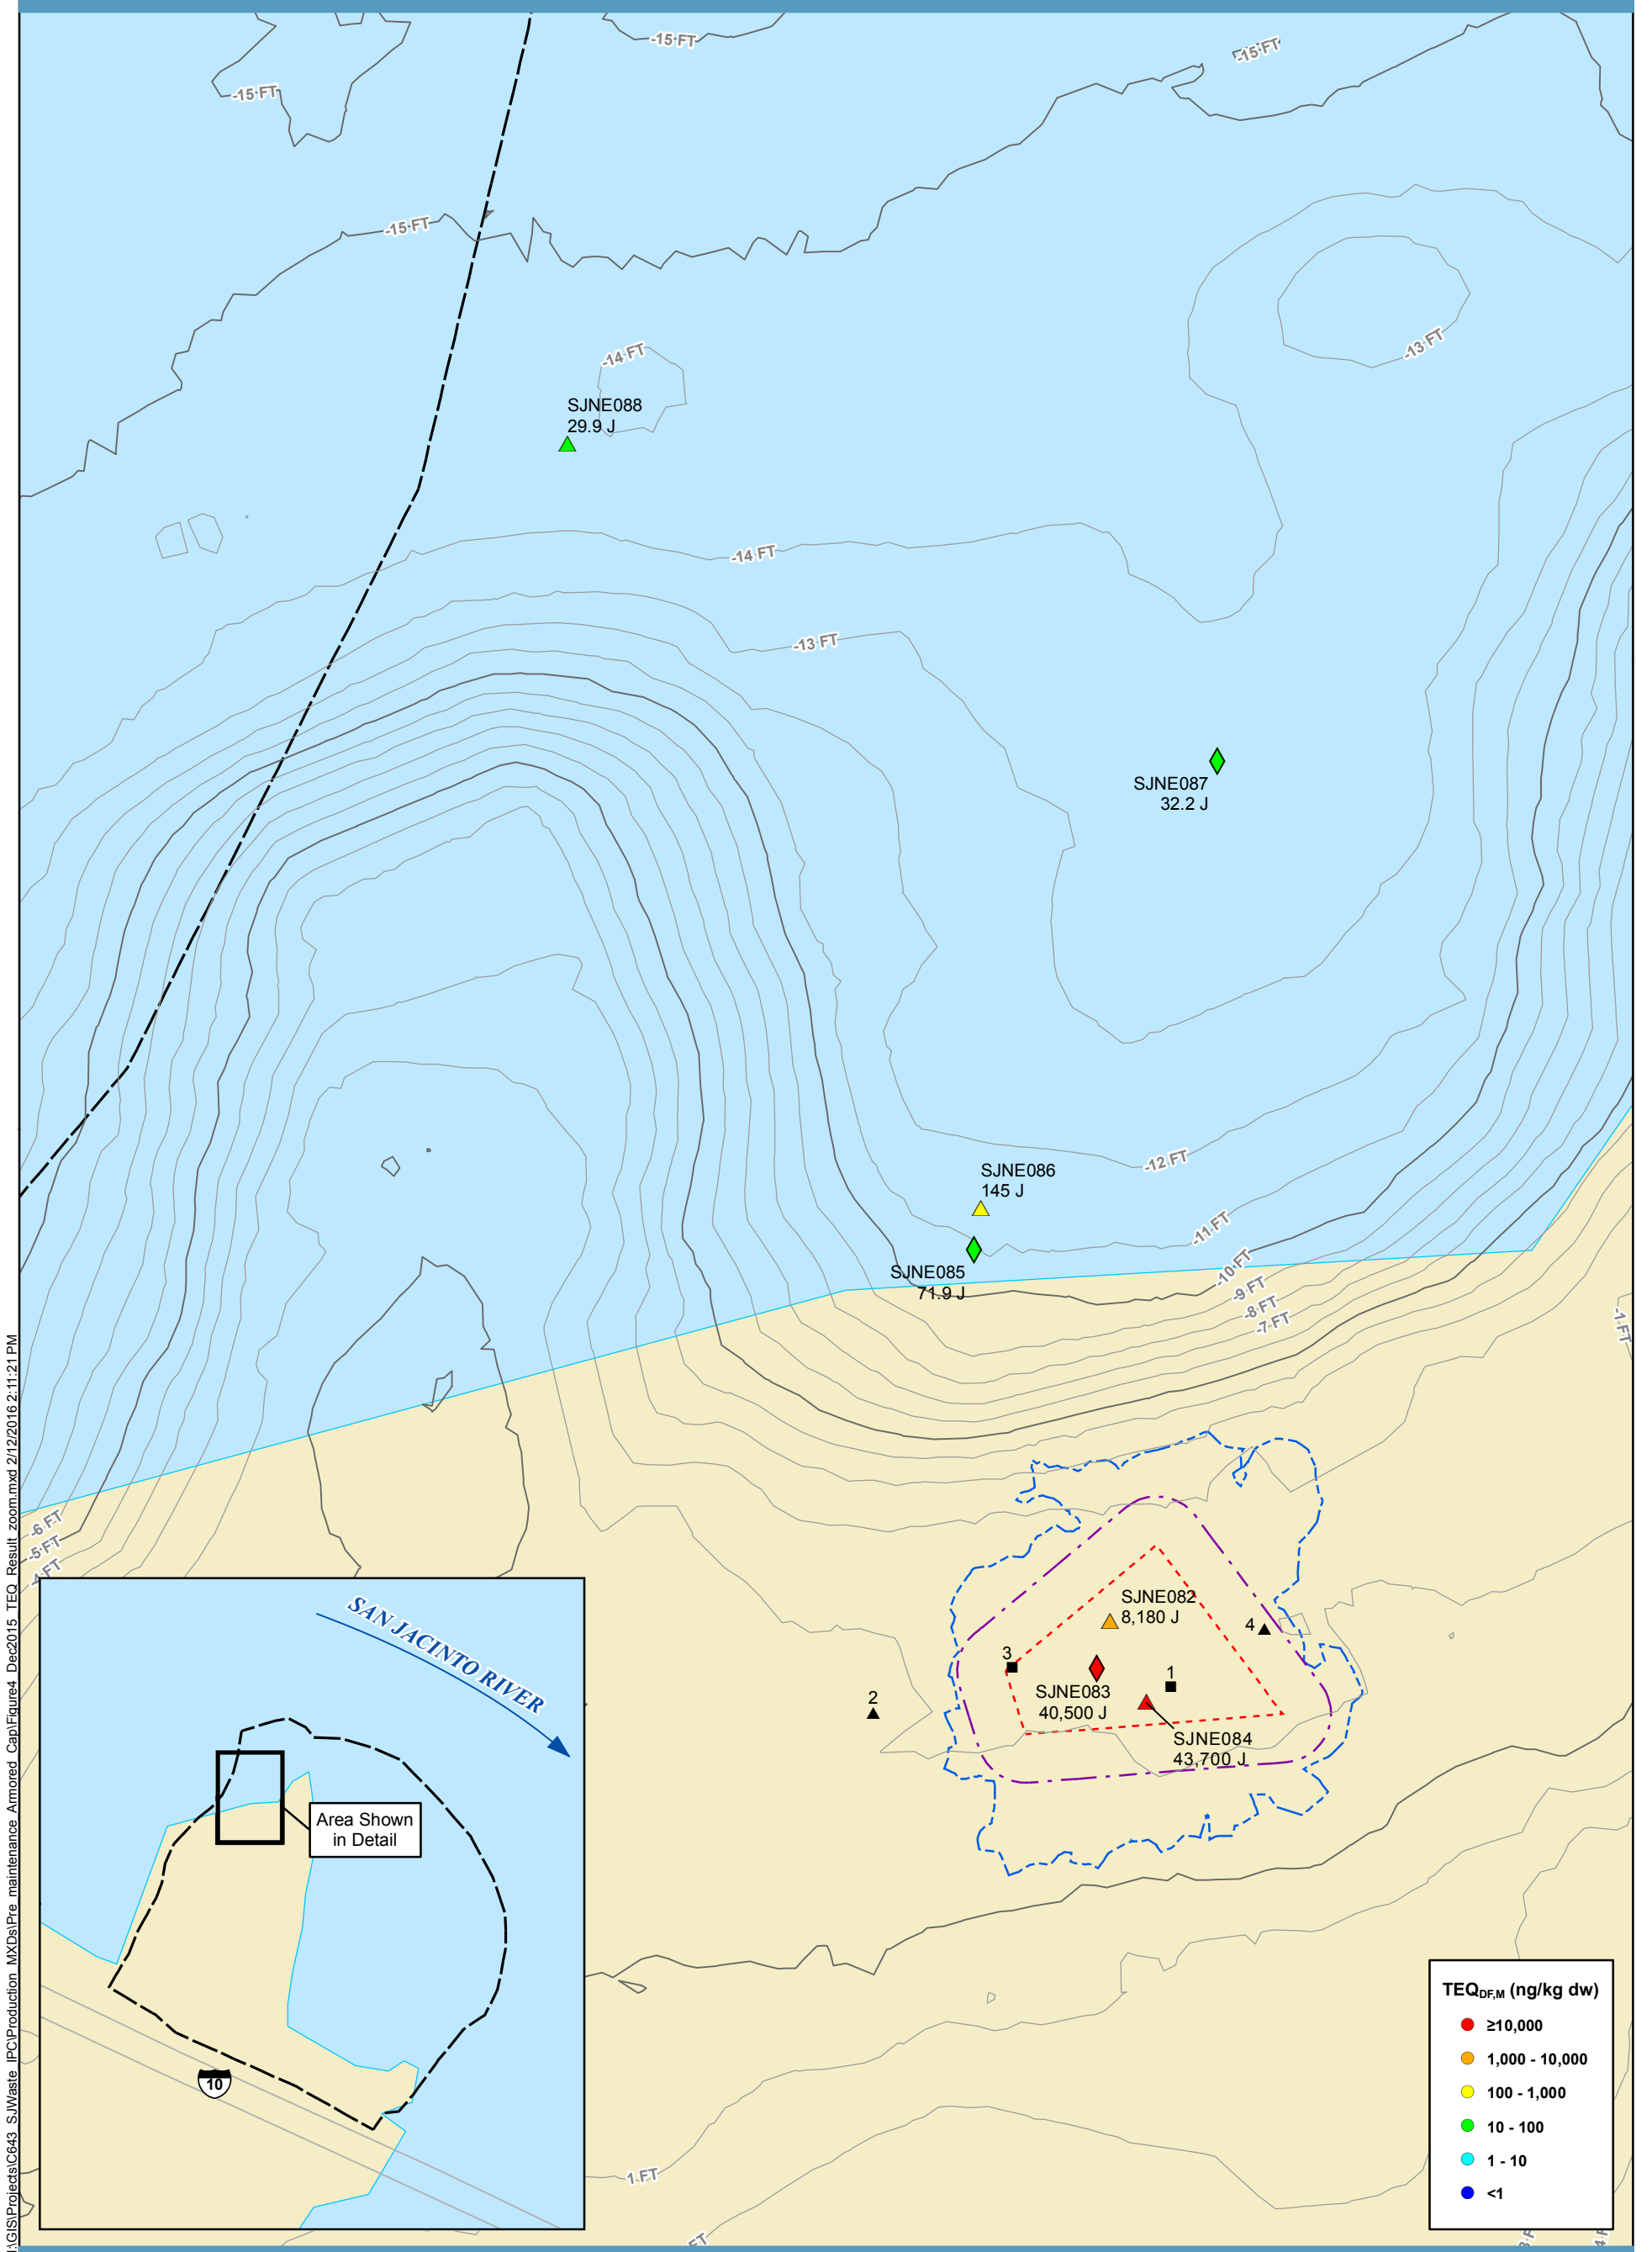
- △ December 2015 Sediment Sample
- ◇ December 2015 Sediment Sample (Split)
- ▲ USEPA Probe Location (December 2015), Rock
- USEPA Probe Location (December 2015), Sediment

- October 2015 Bathymetric and Topographic Contours (1-ft interval)
- Toe of Actual Armor Rock Placement
- Toe of Proposed Armor Rock Placement
- Extent of Required Overlap
- Original 1966 Perimeter of the Impoundments North of I-10
