Figure 3-6
 General Stratigraphy of the Impoundments North of I-10, Cross Section A-A'
 Remedial Investigation Report
 San Jacinto River Waste Pits Superfund Site

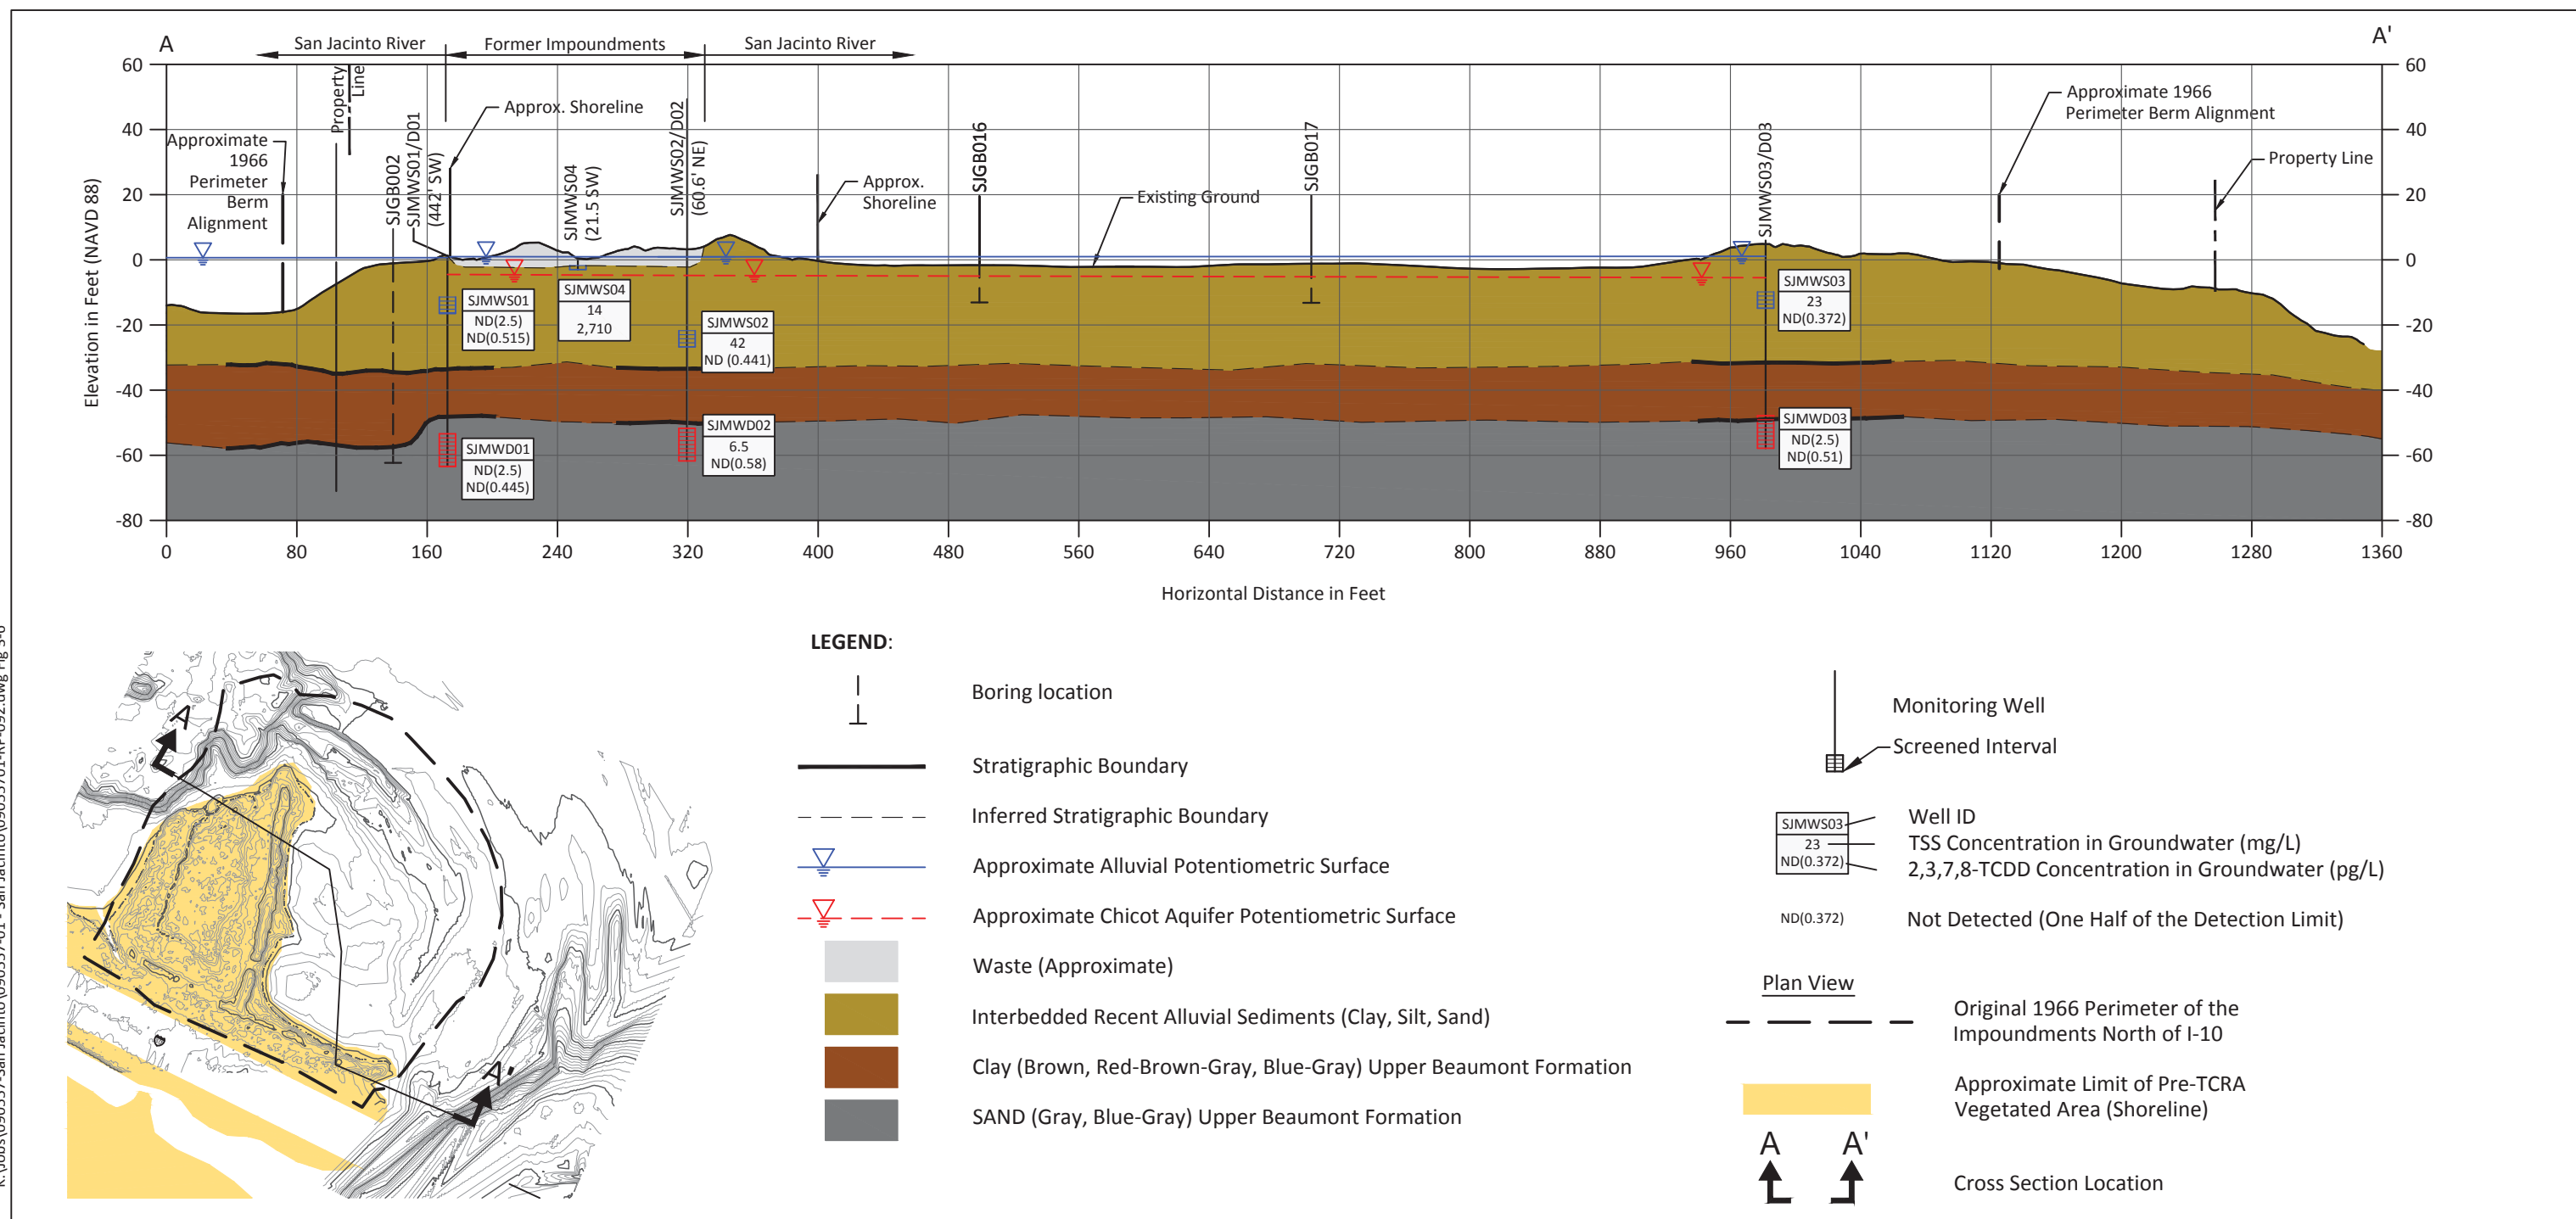
SOURCE: Drawing prepared from USACE. Bathymetry has been compiled from a 2/16/09 and 6/12/10 survey conducted by Hydrographic Consultants, LTD of Bellaire, Texas. Upland contours generated from LiDAR data collected by Merrick & Co., published 11/4/2008.
HORIZONTAL DATUM: Texas South Central NAD 83, US Survey Feet.
VERTICAL DATUM: NAVD 88.
NOTES:
 1. Deep wells are double cased (not depicted) into Upper Beaumont Clay.
